July 13, 2018

RE: Response to Notice of Violation Issued to Advanced Disposal Services Eagle Point Landfill
Permit No. 058-012D, Forsyth County

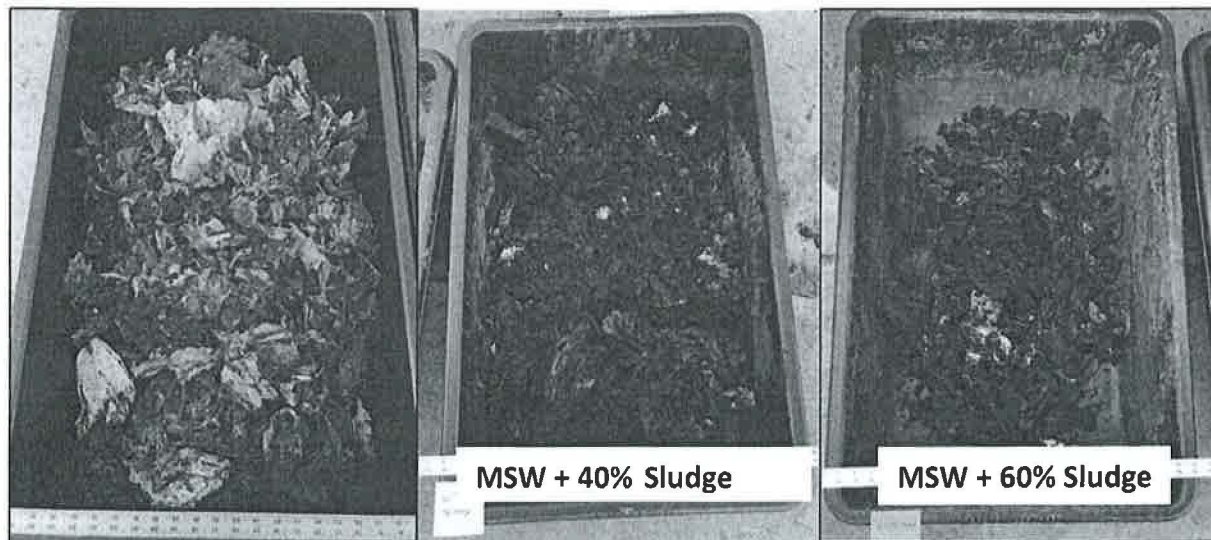
Large-scale direct shear tests were conducted on the mixtures following the methodology in Bareither et al. (2012) and ASTM D3080 using overburden stresses up to 170 kPa to simulate different depths of waste. Shear strength envelopes for the waste with varying LSSW content (0-100%) are shown in the figure below along with the envelope recommended for design of MSW landfills (dashed line) by Kavazanjian et al. (1995). The slope of the envelope is indicative of the shearing friction in the waste (steeper slope corresponds to waste with greater friction and higher strength). The slope is described by the friction angle (ϕ'). The intercept, corresponding to strength under no confinement, is the cohesion (c'). Wastes with higher ϕ' and c' have greater strength.

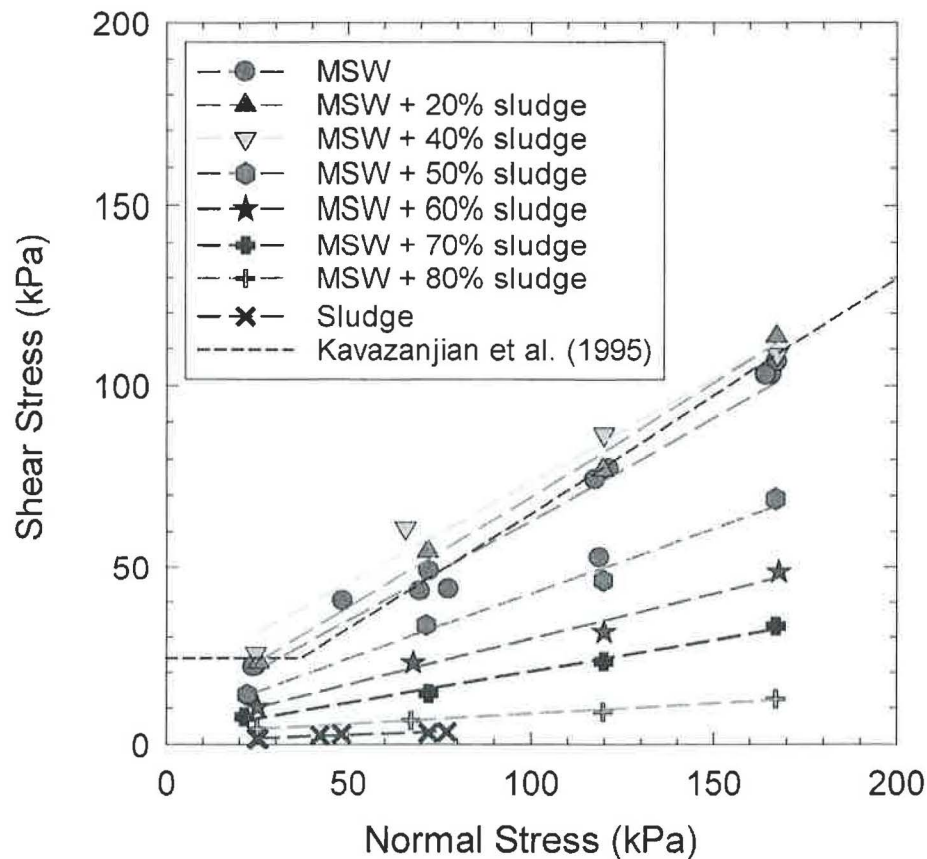
The data in the figure indicates that the MSW without LSSW has comparable strength as the generalized recommendation for strength of MSW in Kavazanjian et al. (1995). The test results also show that the strength is unaffected by LSSW content until the LSSW content exceeds 40%. At ratios exceeding 40%, the strength decreases (slope of the envelope, or ϕ' , decreases) as the LSSW content increases.
